### **INSPECTION DATE**

09/29/2003 1:00 pm to 3:30 pm

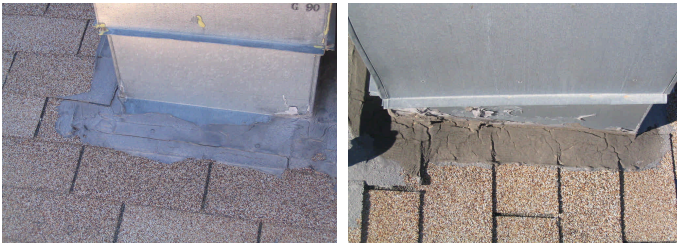
- The roof flashings need to be sealed or serviced. They are comprised of metal that seals valleys and vents and other roof penetrations, and are the most common point of leaks. This is particularly true of the flashings on a layered roof, which are covered by the roofing material and which are even more susceptible to leaks.
