Offering Quality Home Inspections to S.E. Arizona

SUMMARY REPORT

Inspection Address: 123 America Ave, Sierra Vista, AZ 85635
Inspection Date: 4/24/2012 Start: 9:00 am End: 11:30 am
Weather: Clear and Dry
Temperature: 70-80 Degrees
Inspected by: Travis Weddle

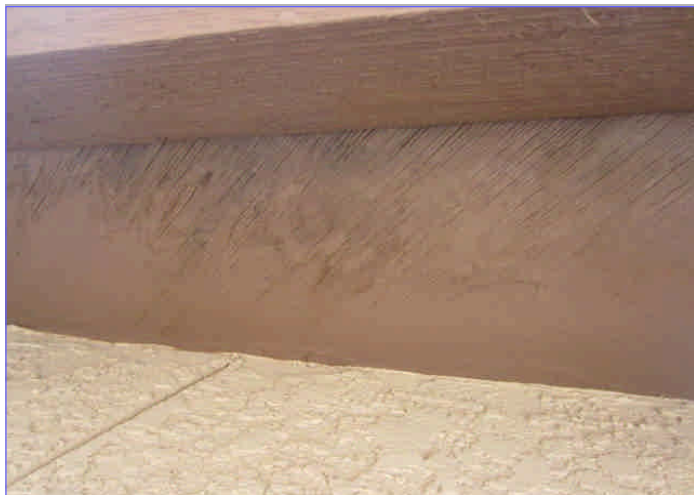
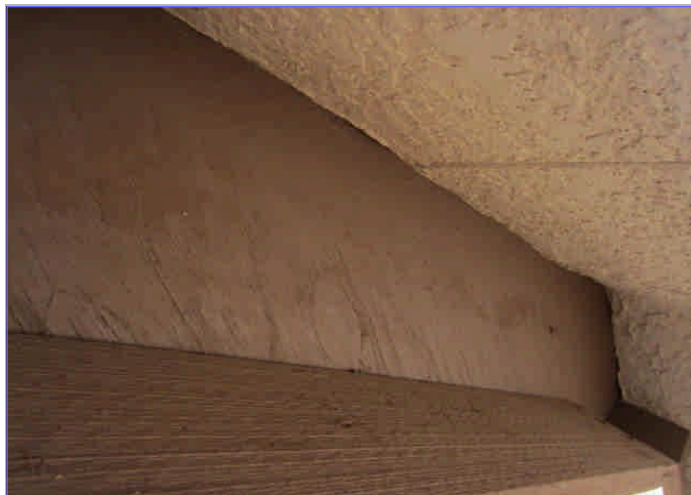
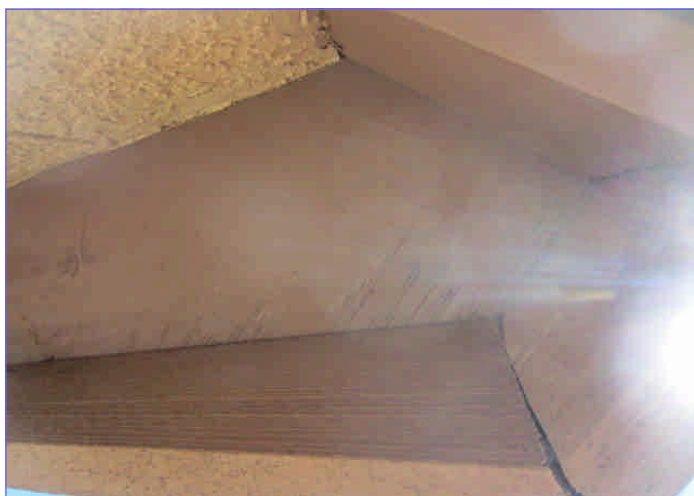
- 1.1 There are one or more areas where the fascia, trim, eave or soffit are water damaged and should be repaired or replaced. (under edge tiles by bay windows, see roofing specialist about possible preventive repairs)

There are one or more areas where the fascia or trim are water damaged and should be replaced - *Continued*

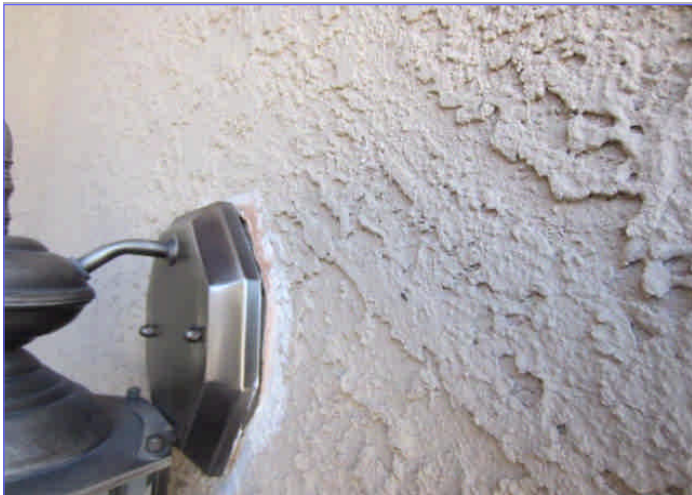
- 1.2 One or more exterior lights need to be sealed and/or secured to the wall.

One or more exterior lights need to be sealed and secured to the wall - *Continued*

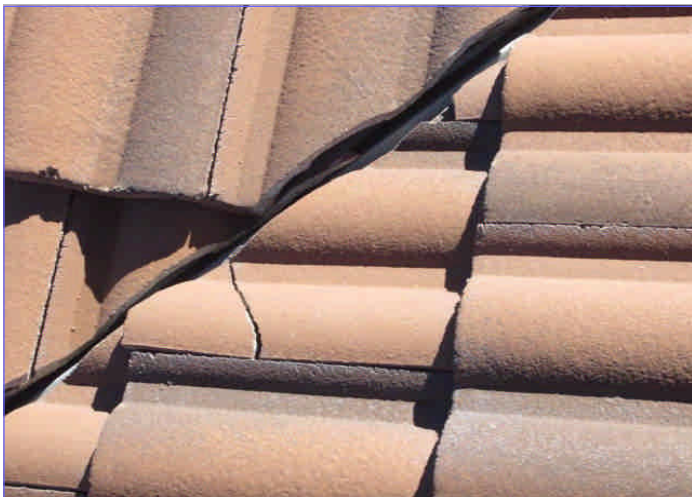
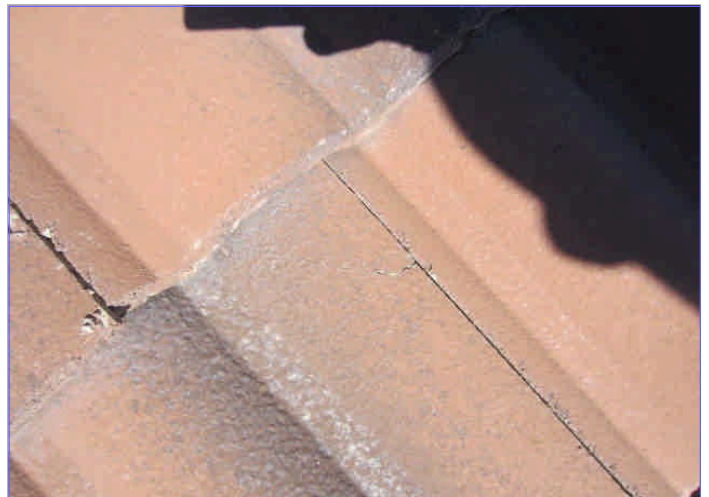
3.1 There are a number of cracked or broken or missing tiles that should be serviced.

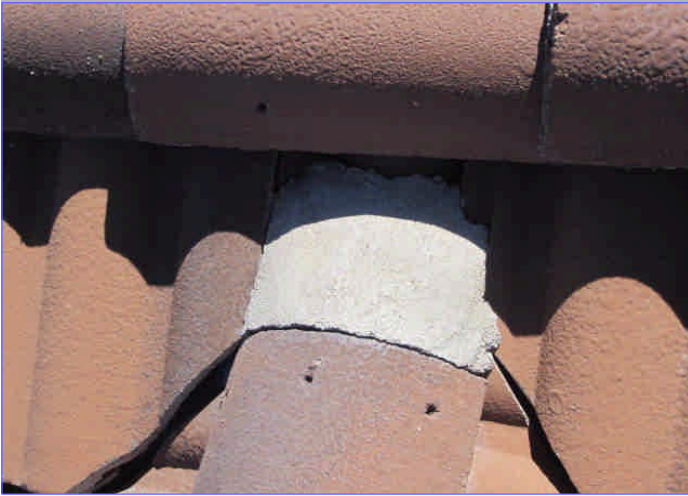
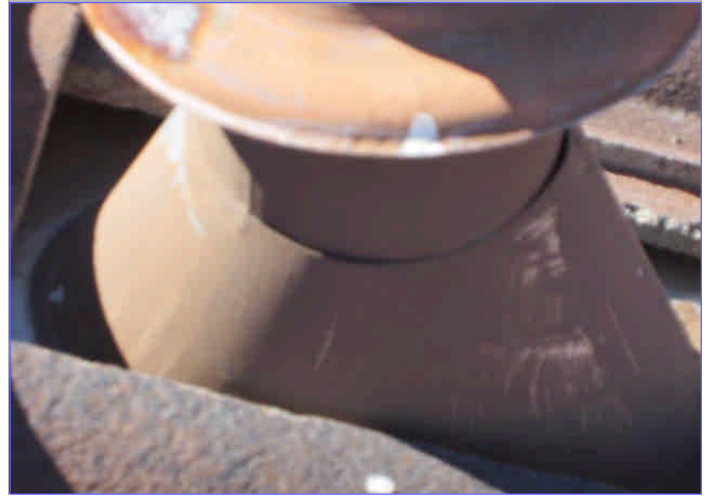
3.3 The roof flashings need to be sealed or serviced. They are comprised of metal that seals valleys and vents and other roof penetrations, and are the most common point of leaks. This is particularly true of the flashings on a layered roof, which are covered by the roofing material and which are even more susceptible to leaks.

The roof flashings need to be sealed or serviced - *Continued*

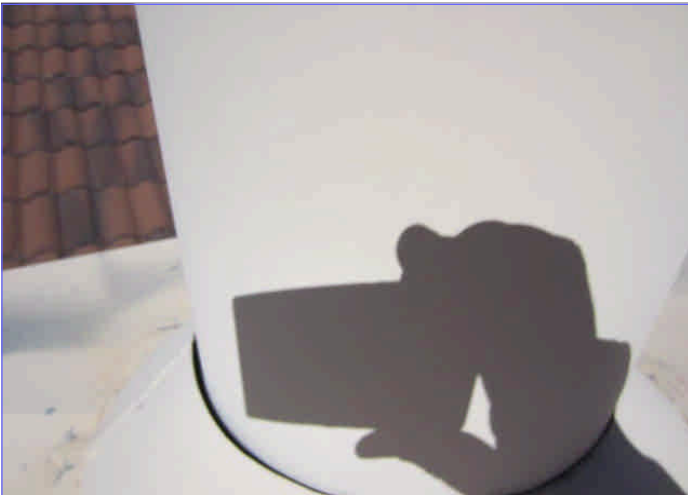
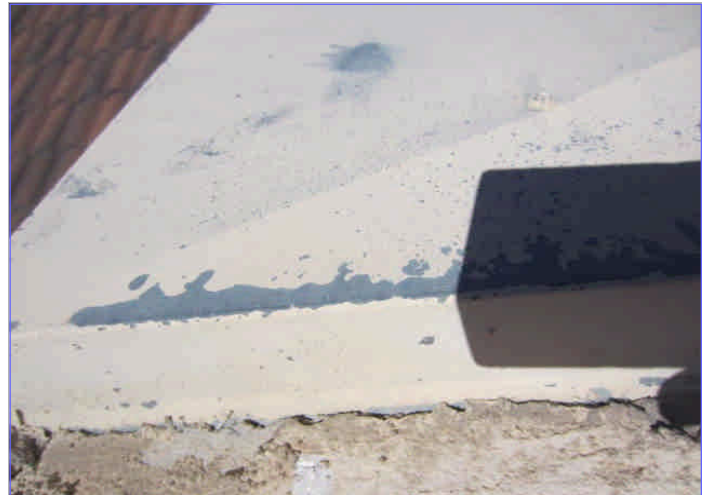
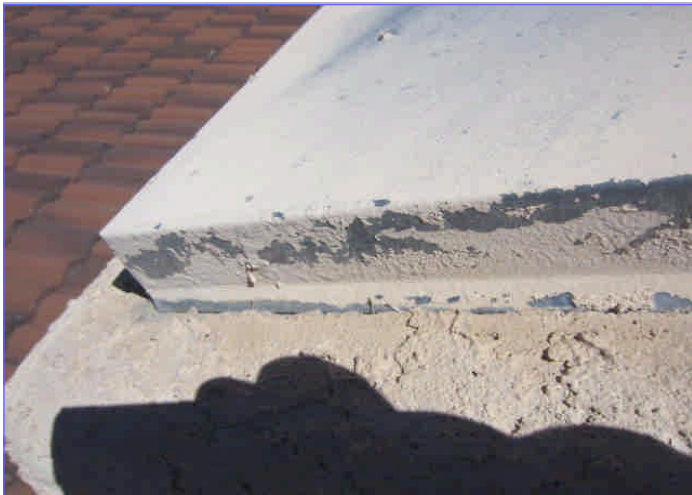
4.1 The termination cap should be sealed to prevent moisture intrusion into the chimney walls and fireplace.

The termination cap should be sealed to prevent moisture intrusion - *Continued*

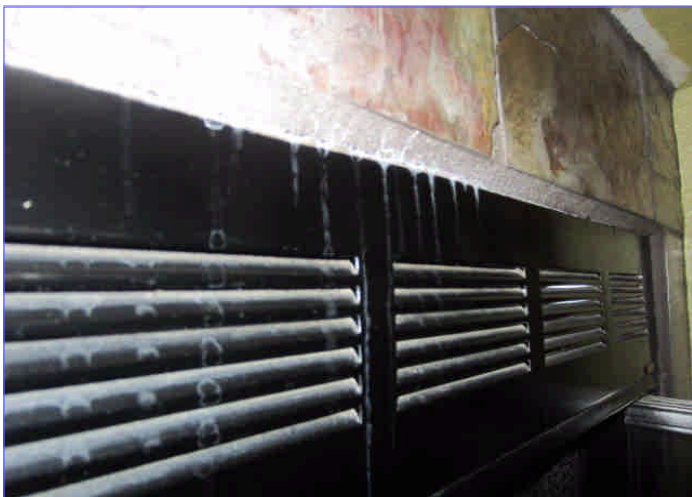
- 4.2 The void around the gas pipe in the sidewall of the fireplace should be sealed with refractory caulk to prevent any possibility of back-drafting a flame beyond the combustion chamber, where it could come into contact with combustible material.
- 4.3 There are many water stains on the fireplace and in the fireplace. This condition should be further evaluated by a fireplace specialist to ensure that is only needs to be sealed on the roof.

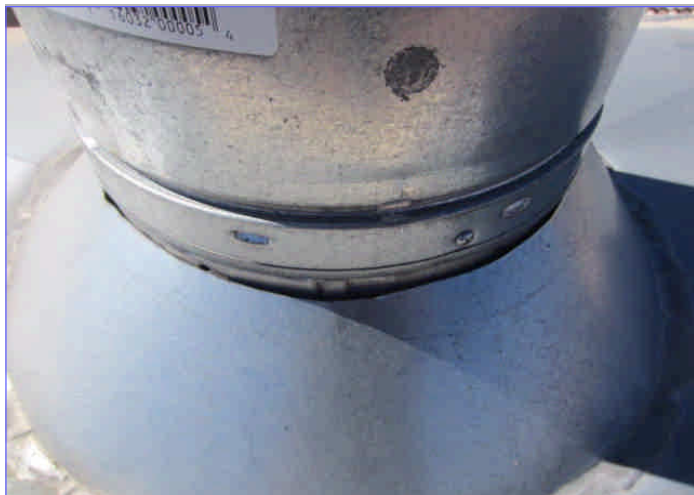
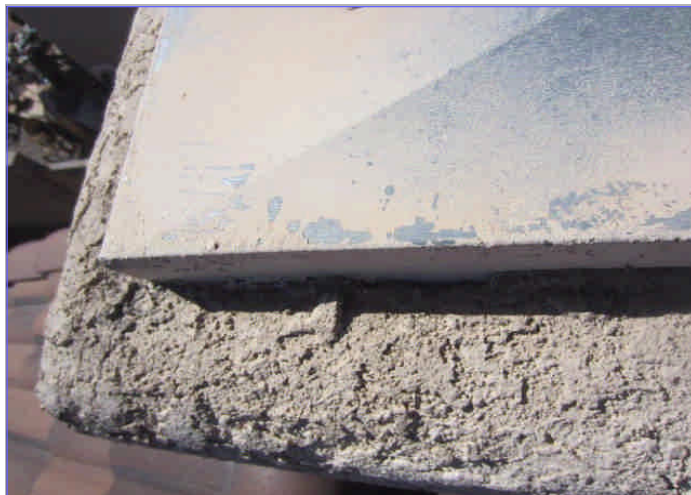
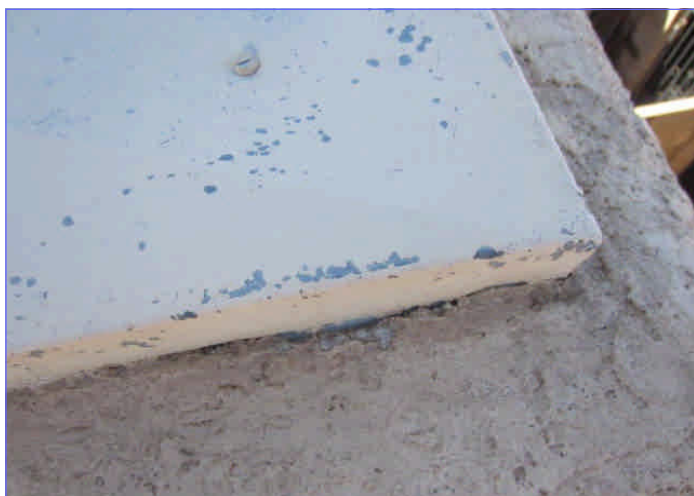
- 4.4 The crown should be sealed to prevent moisture intrusion.

The flashing on the crown should be sealed to prevent moisture intrusion - *Continued*

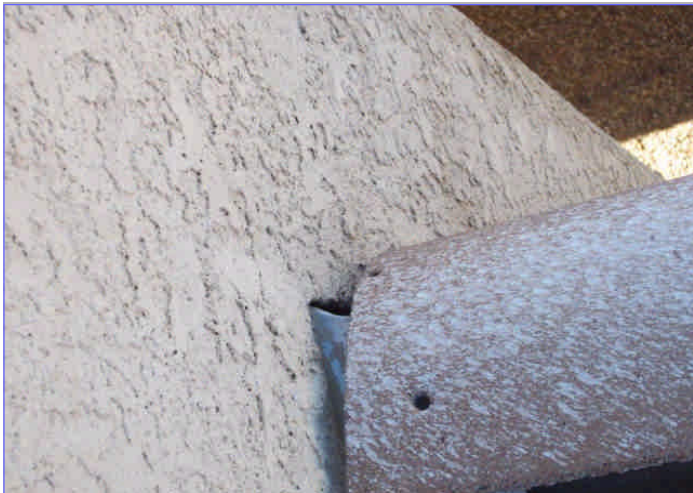
4.5 The flashing's of the chimney need to be resealed.

The vertical wall flashings of the chimney need to be resealed - *Continued*

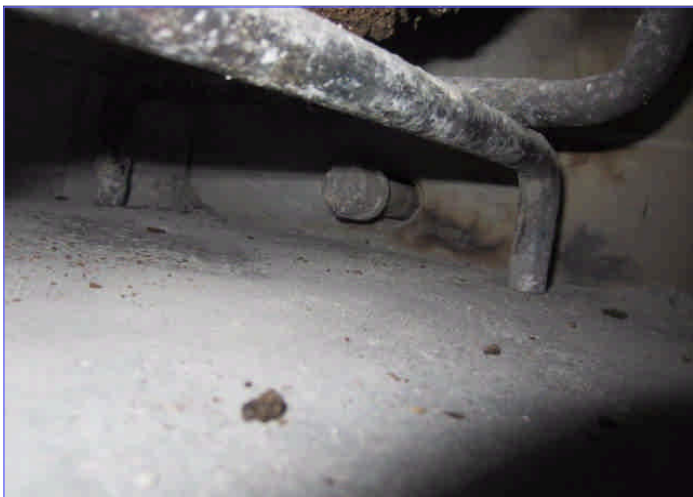
- 4.6 The fireplace has moisture stains in or on it, which the cause should be resealed to prevent moisture damage.
- 4.7 The void around the gas pipe in the sidewall of the fireplace should be sealed with refractory caulk to prevent any possibility of back-drafting a flame beyond the combustion chamber, where it could come into contact with combustible material.

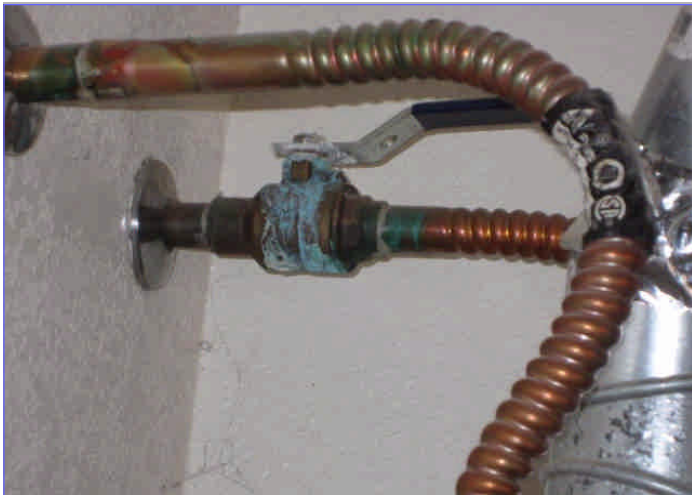
- 5.2 There is mineral encrustation on the fittings, which should be cleaned to ensure that the fittings are not still leaking.

There is mineral encrustation on the fittings that should be cleaned - *Continued*

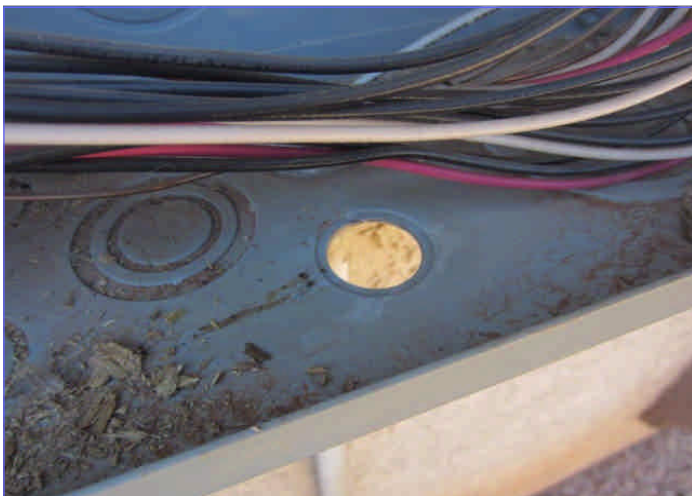
- 6.1 There are voids in the main panel that should be covered by a electrical specialist.

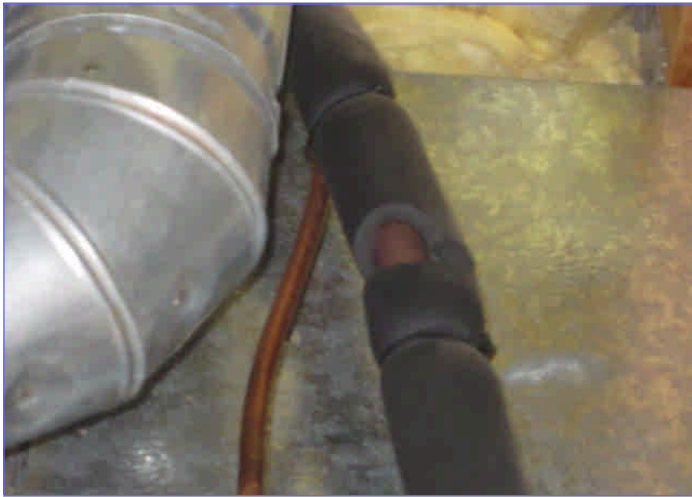
- 8.2 Insulation is missing or damaged from the refrigerant lines at the evaporator coil and or condensing coil which will allow condensation to form and drip, and should be installed.

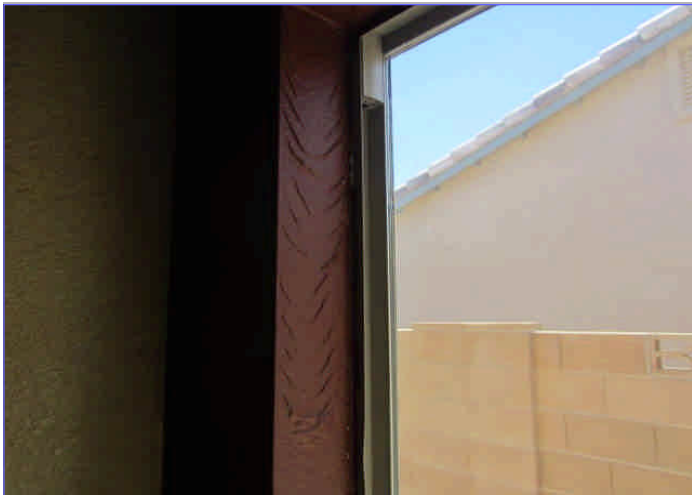
- 9.3 There is a moisture stain/damage on the ceiling/walls, which you should ask the sellers to explain or have explored further. (down hill from chimney, left side if window on left of chimney)

There is a moisture stain on the ceiling that should be explained or further evaluated - *Continued*

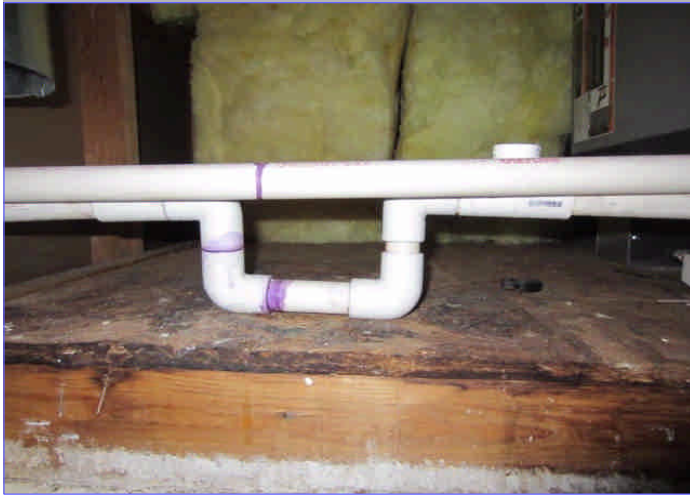
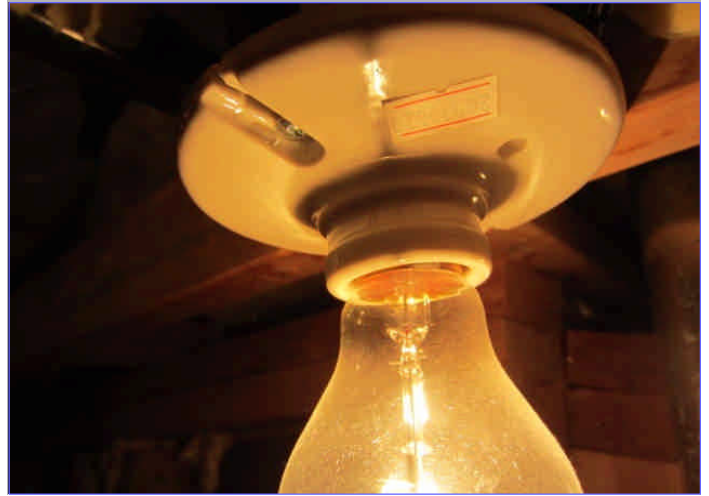
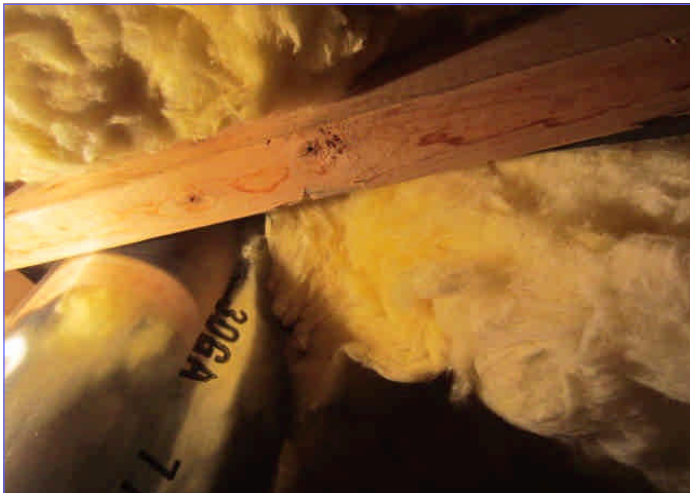
- 13.1 There is evidence that the roof has leaked, which should be reasonably explained, or the roof should be evaluated by a specialist. (stains on truss, damage to OSB deck, rust in light bulb mounted to truss)

There is evidence that the roof has leaked which should be reasonably explained or explored further - *Continued*

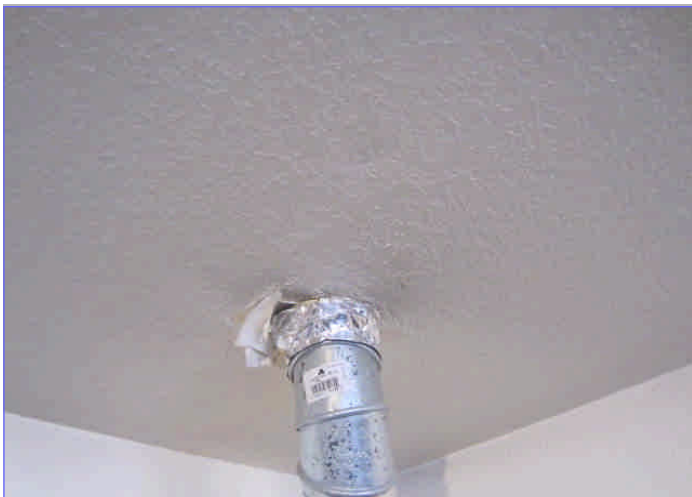
17.1 There is a moisture stain/damage on the garage ceiling, the cause of which should be explained or explored further. However, we not unable to confirm that is being caused by an active leak. (around water heater vent)

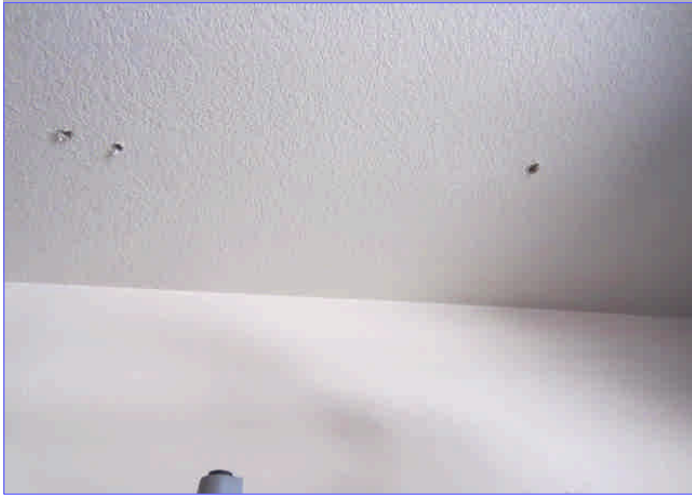
17.2 The voids in the garage firewall must be repaired, in order to maintain the necessary firewall separation between the garage and the residence.

The voids in the garage firewall must be repaired - *Continued*

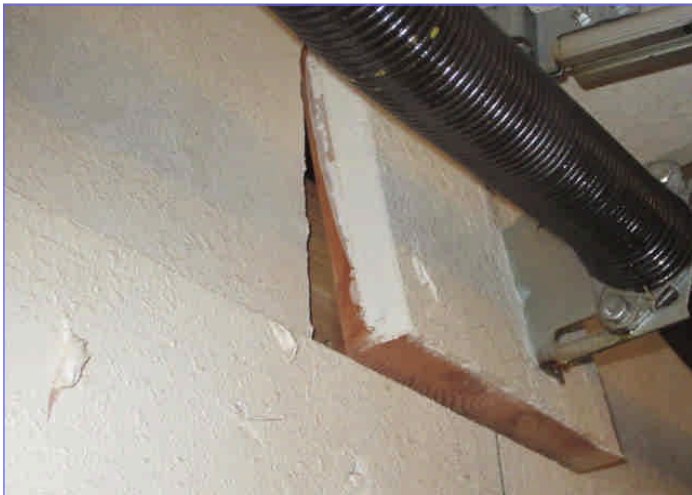
- 17.3 The springs on the garage door should be adjusted to prevent the door from opening or closing on its own.
- 17.4 The garage door needs to be serviced to move smoothly.
- 17.5 It appears the garage door springs are pulling off the blocking used to secure them. This condition should be further evaluated and repaired as needed by a garage door specialist.

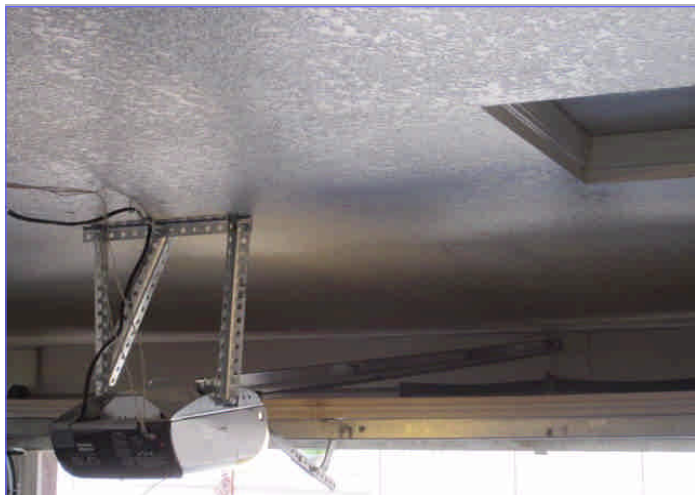
- 17.6 The garage door opener should be serviced for the following reasons: Appears to installed to low, this is possible causing the opener to open roughly. Garage door hit opener when opening instead of stopping before the unit.

The garage door opener should be serviced for the following reasons - *Continued*

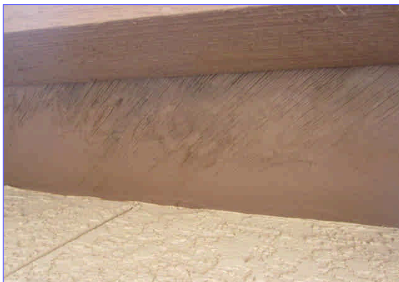
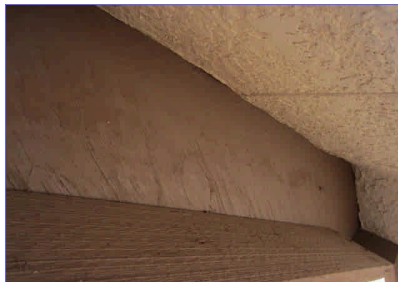
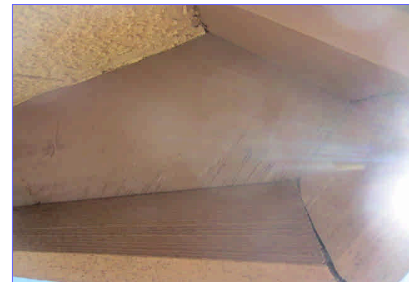
There are one or more areas where the fascia, trim, eave or soffit are water damaged and should be repaired or replaced. (under edge tiles by bay windows, see roofing specialist about possible preventive repairs)

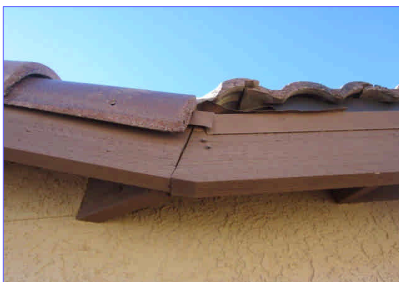
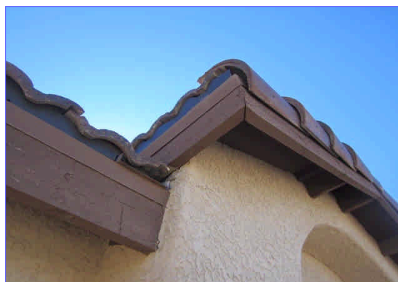
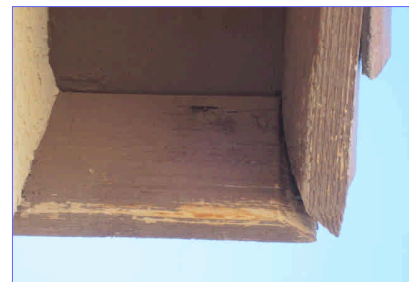
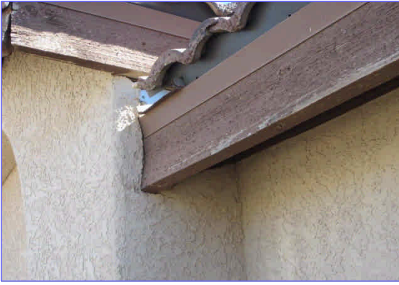
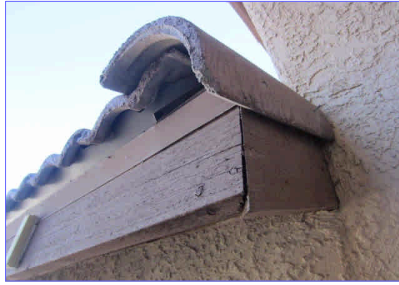
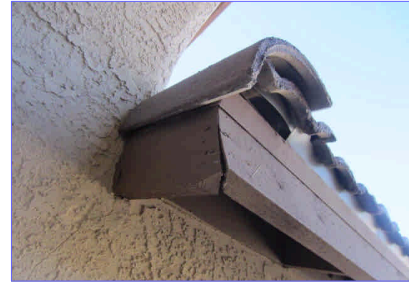
Sections of the fascia, trim, eave or soffit area need maintenance type service, and particularly on the south facing side where they are exposed to direct sunlight. (paint and seal)

The fascia trim eave or soffit areas need typical maintenance-type service - *Continued*

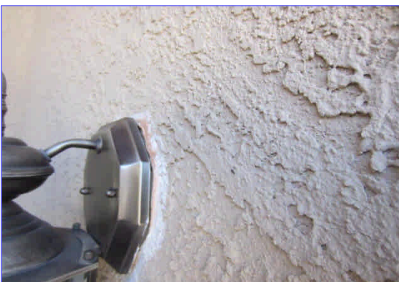
One or more exterior lights need to be sealed and/or secured to the wall.

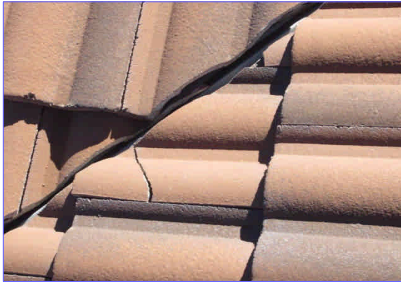
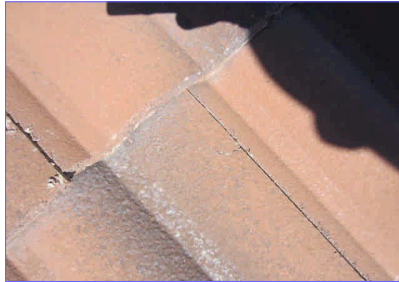
There are a number of cracked or broken or missing tiles that should be serviced.

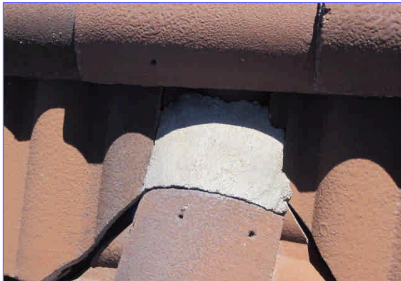
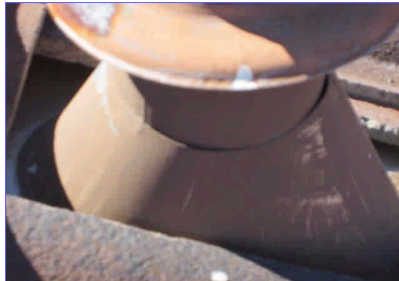
The roof flashings need to be sealed or serviced. They are comprised of metal that seals valleys and vents and other roof penetrations, and are the most common point of leaks. This is particularly true of the flashings on a layered roof, which are covered by the roofing material and which are even more susceptible to leaks.

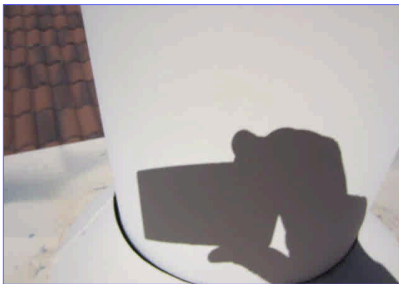
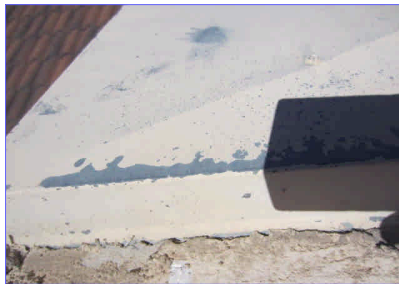
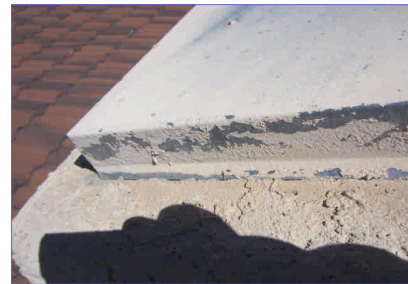
The termination cap should be sealed to prevent moisture intrusion into the chimney walls and fireplace.

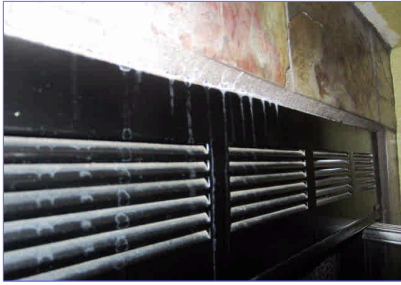
There are many water stains on the fireplace and in the fireplace. This condition should be further evaluated by a fireplace specialist to ensure that is only needs to be sealed on the roof.

There are many water stains on the fireplace and in the fireplace - *Continued*

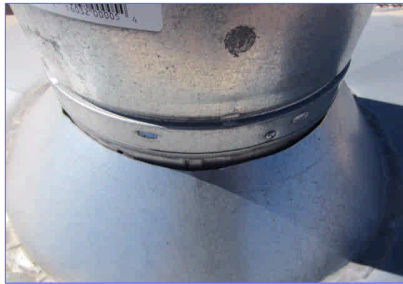
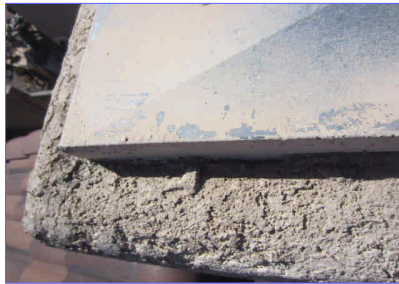
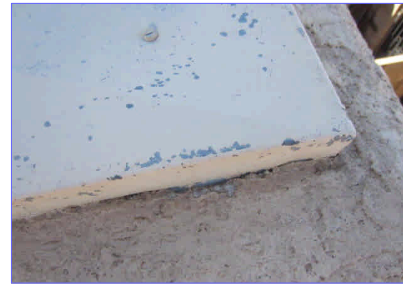
The crown should be sealed to prevent moisture intrusion.

The flashing on the crown should be sealed to prevent moisture intrusion - *Continued*

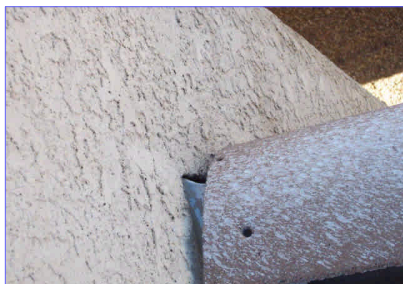
The flashing's of the chimney need to be resealed.

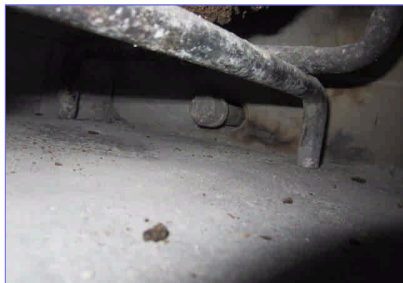
The fireplace has moisture stains in or on it, which the cause should be resealed to prevent moisture damage. The void around the gas pipe in the sidewall of the fireplace should be sealed with refractory caulk to prevent any possibility of back-drafting a flame beyond the combustion chamber, where it could come into contact with combustible material.

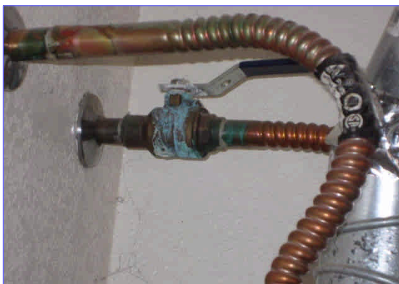
There is mineral encrustation on the fittings, which should be cleaned to ensure that the fittings are not still leaking.

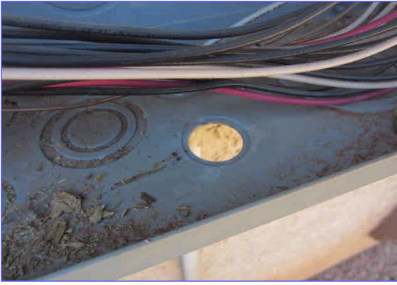
There are voids in the main panel that should be covered by an electrical specialist.

There are voids in the main panel that should be covered by a electrical specialist - *Continued*

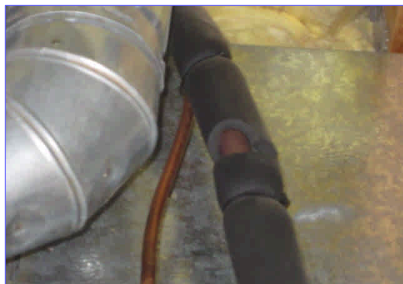
Insulation is missing or damaged from the refrigerant lines at the evaporator coil and or condensing coil which will allow condensation to form and drip, and should be installed.

Insulation is missing or damaged from the refrigerant lines at the evaporator coil and should be replaced - *Continued*

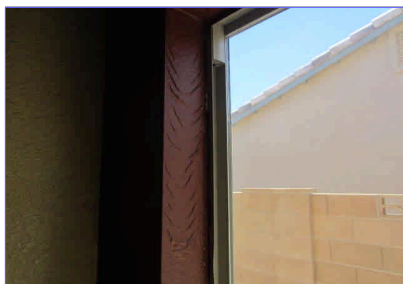
There is a moisture stain/damage on the ceiling/walls, which you should ask the sellers to explain or have explored further. (down hill from chimney, left side if window on left of chimney)

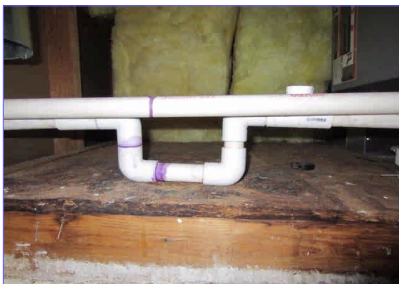
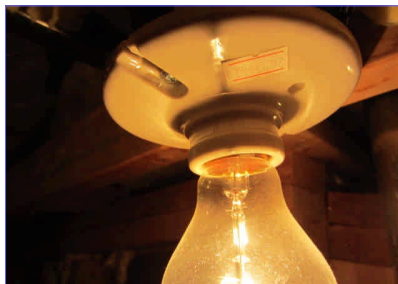
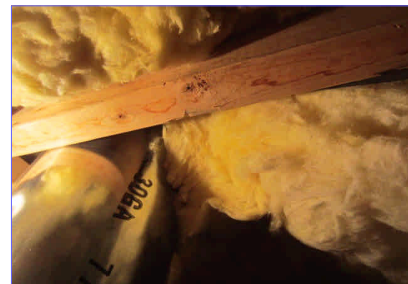
There is evidence that the roof has leaked, which should be reasonably explained, or the roof should be evaluated by a specialist. (stains on truss, damage to OSB deck, rust in light bulb mounted to truss)

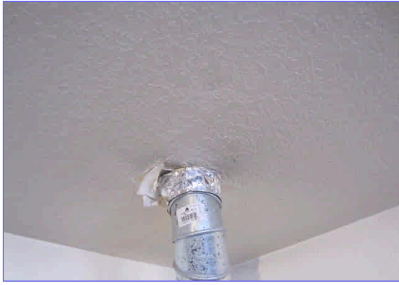
There is a moisture stain/damage on the garage ceiling, the cause of which should be explained or explored further. However, we not unable to confirm that is being caused by an active leak. (around water heater vent)

There is a moisture stain on the garage ceiling the cause of which should be explained or explored - *Continued*

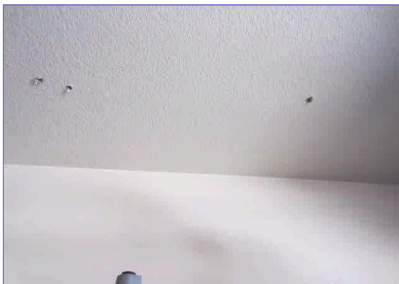
The voids in the garage firewall must be repaired, in order to maintain the necessary firewall separation between the garage and the residence.

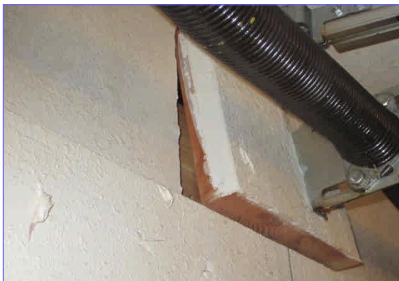
The springs on the garage door should be adjusted to prevent the door from opening or closing on its own. The garage door needs to be serviced to move smoothly.

It appears the garage door springs are pulling off the blocking used to secure them. This condition should be further evaluated and repaired as needed by a garage door specialist.

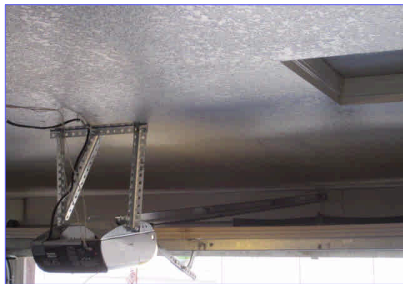
the unit.
